脉冲激光对石英基底Ta₂O₅/SiO₂滤光膜的损伤效应研究

王云哲 张鲁薇 邵俊峰 曲卫东 康华超 张引

Damage effect of pulsed laser on Ta₂O₅/SiO₂ filter film on quartz substrate

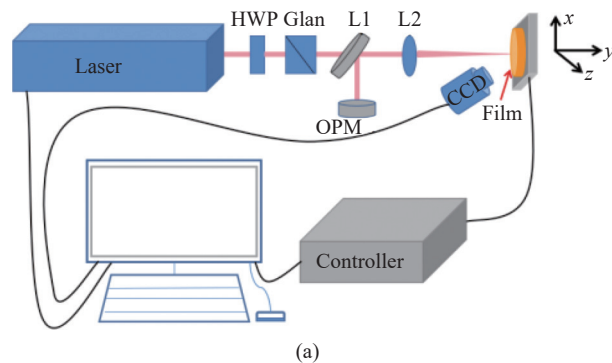
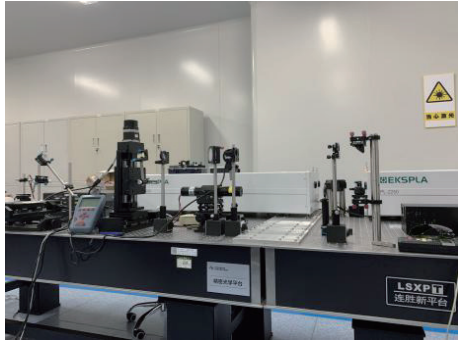
图 2(a) 给出了滤光膜损伤实验的装置。激光器输出激光后,通过可旋转的半波片(HWP)和格兰棱镜(Glan)对输出的脉冲能量进行调控,分束镜(L1(固定分光比)用于对激光能量进行采样,由能量计实时监测,聚焦镜 L2 用于对激光束进行聚焦。待测样品被固定在一个由计算机控制的电动三维平移台,一个显微镜和 CCD 相机用于实时观测激光对薄膜损伤的实验过程,实验结束后使用金相显微镜(台湾奕叶 EB-4)细致观测薄膜的损伤形貌。

图 2 (a) 光学薄膜损伤示意图; (b) 光学薄膜损伤实验平台

Fig.2 (a) Schematic diagram of laser damage to optical thin films;

(b) Experimental platform of laser damage to optical thin films

实验采用 Ti: sapphire 脉冲放大系统输出飞秒激光,其波长、脉宽分别为 800 nm 和 50 fs,偏振状态为线偏振。所采用的皮秒激光器为 EKSPILA 公司的 Nd: YAG 皮秒激光器,具有二级管泵浦的固态主振荡器和闪光等泵浦的再生放大器,其波长为 1064 nm/532 nm,脉宽为 50 ps。纳秒激光器为 Nimma-900 纳秒激光器,脉宽为 9 ns,输出激光波长为 1064 nm/532 nm。

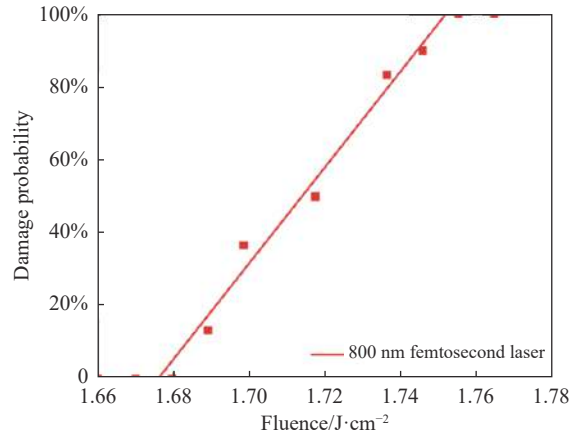
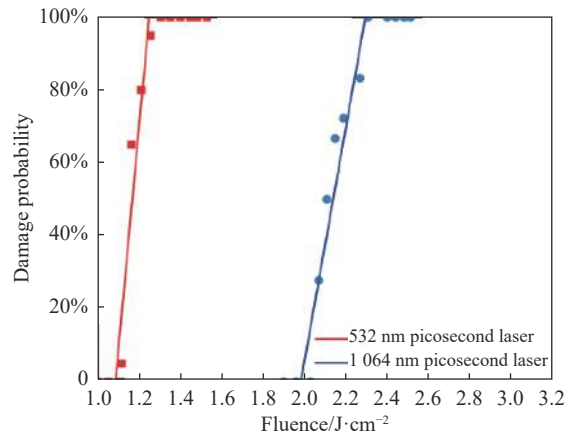
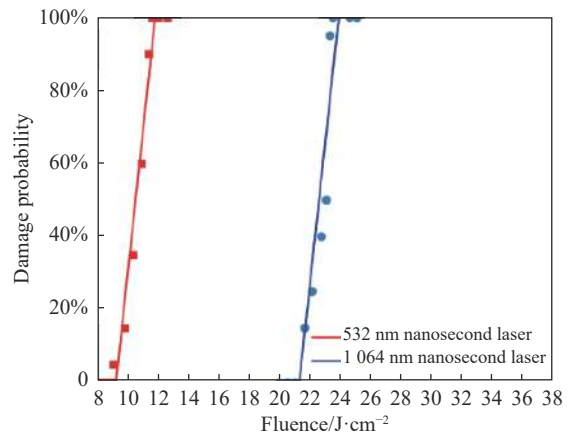
飞秒、皮秒及纳秒激光对样品的损伤概率随脉冲输出能量变化如图 3 所示。根据图 3 可以得到样品 $800\ \text{nm}$ 飞秒激光损伤阈值为 $1.67\ \text{J}/\text{cm}^2$; 波长 $532\ \text{nm}$ 和 $1064\ \text{nm}$ 皮秒激光输出条件下损伤阈值分别为 $1.08\ \text{J}/\text{cm}^2$ 和 $1.98\ \text{J}/\text{cm}^2$; 波长 $532\ \text{nm}$ 和 $1064\ \text{nm}$ 纳秒激光输出条件下损伤阈值分别为 $9.39\ \text{J}/\text{cm}^2$ 和 $21.57\ \text{J}/\text{cm}^2$ 。总结实验结果发现, 无论是透射通带内还是通带外, 纳秒激光作用下光学薄膜的损伤阈值最高, 飞秒激光损伤阈值与皮秒激光损伤阈值相当。纳秒激光损伤

阈值要比飞秒激光损伤阈值和皮秒激光损伤阈值高一个量级。

图 3 飞秒、纳秒和皮秒激光对滤光膜损伤几率随激光能量密度的变化

Fig.3 Damage probability distribution of multilayer films irradiated by femtosecond, nanosecond and picosecond laser with different laser fluences

在不同脉宽激光作用下,样品损伤行为的不确定性存在差异,即纳秒激光作用下样品损伤行为的不确定性最大,皮秒激光作用下的不确定性较小,飞秒激光作用下几乎不存在损伤行为的不确定性。主要体现在:第一,如图 3 所示,纳秒激光作用下零概率损伤的能量密度与完全损伤的能量密度跨度最大,皮秒其次,飞秒激光作用下的能量密度跨度最小;第二,如图 9 所示,在同一能量密度的激光作用下,纳秒激光损伤区域的面积大小存在的差异较大。这是因为皮秒和纳秒激光作用下样品的损伤取决于膜层中的缺陷,其分布和尺寸都会对膜层的损伤造成影响,研究发现膜层中的缺陷对纳秒激光更加敏感,因此相较于皮秒激光,纳秒激光作用下样品损伤行为的不确定性更大。而飞秒激光作用下,多光子电离是造成膜层损伤的主要原因,自由电子的激发是由膜层材料的本征属性决定的,所以其损伤行为最为确定,不确定性最小。
